TEST REPORT

No. : GZIN2110061529MR

Sample Name : MAGNETIC SPLASH-PROOF CASE FOR IPAD

Model No. : PAD-MSPC10, PAD-ICCB

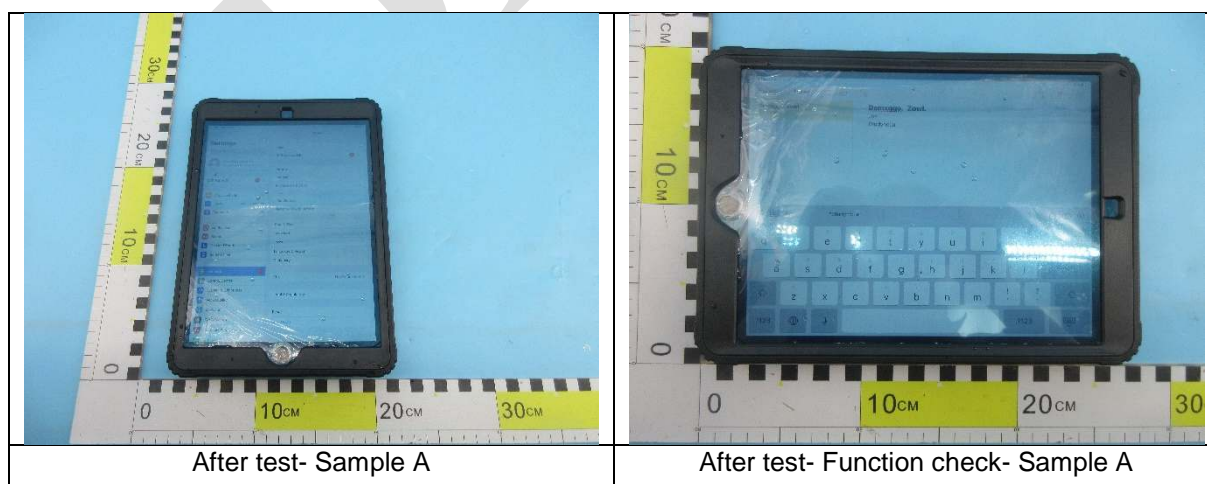
After test- Sample A

After test- Function check- Sample A

Sample	Result	Client's requirement	Conclusion
A	1.No visual ingress of water; 2.After the test, the screen touch could be used.	1.No visual ingress of water; 2.After the test, the screen touch can be used.	Pass
B	No visual ingress of water	No visual ingress of water	Pass

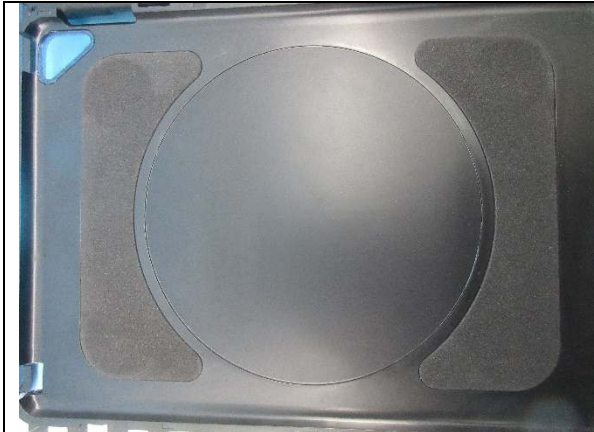
After test-Local part- Sample A

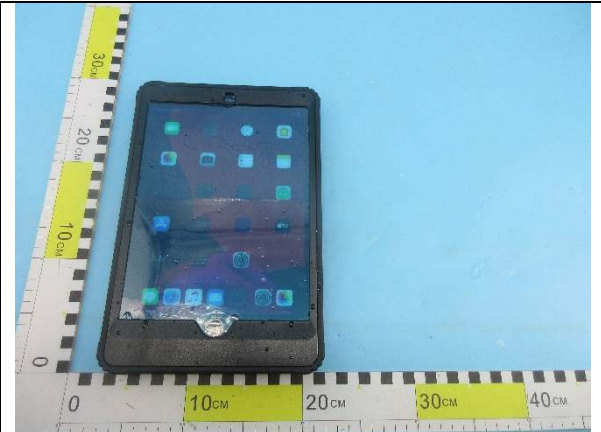
After test- Sample B

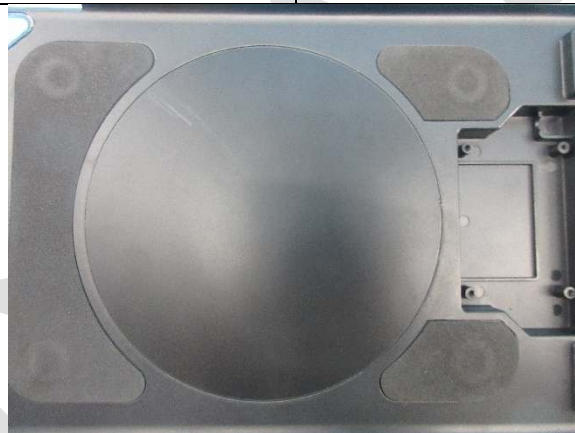
After test-Local part- Sample B
